Tyndall Pilot Project, Submerged Shoreline Stabilization: 60% Basis of Design Report

The Nature Conservancy

Tyndall Pilot Project Design and Permitting

July 24, 2024

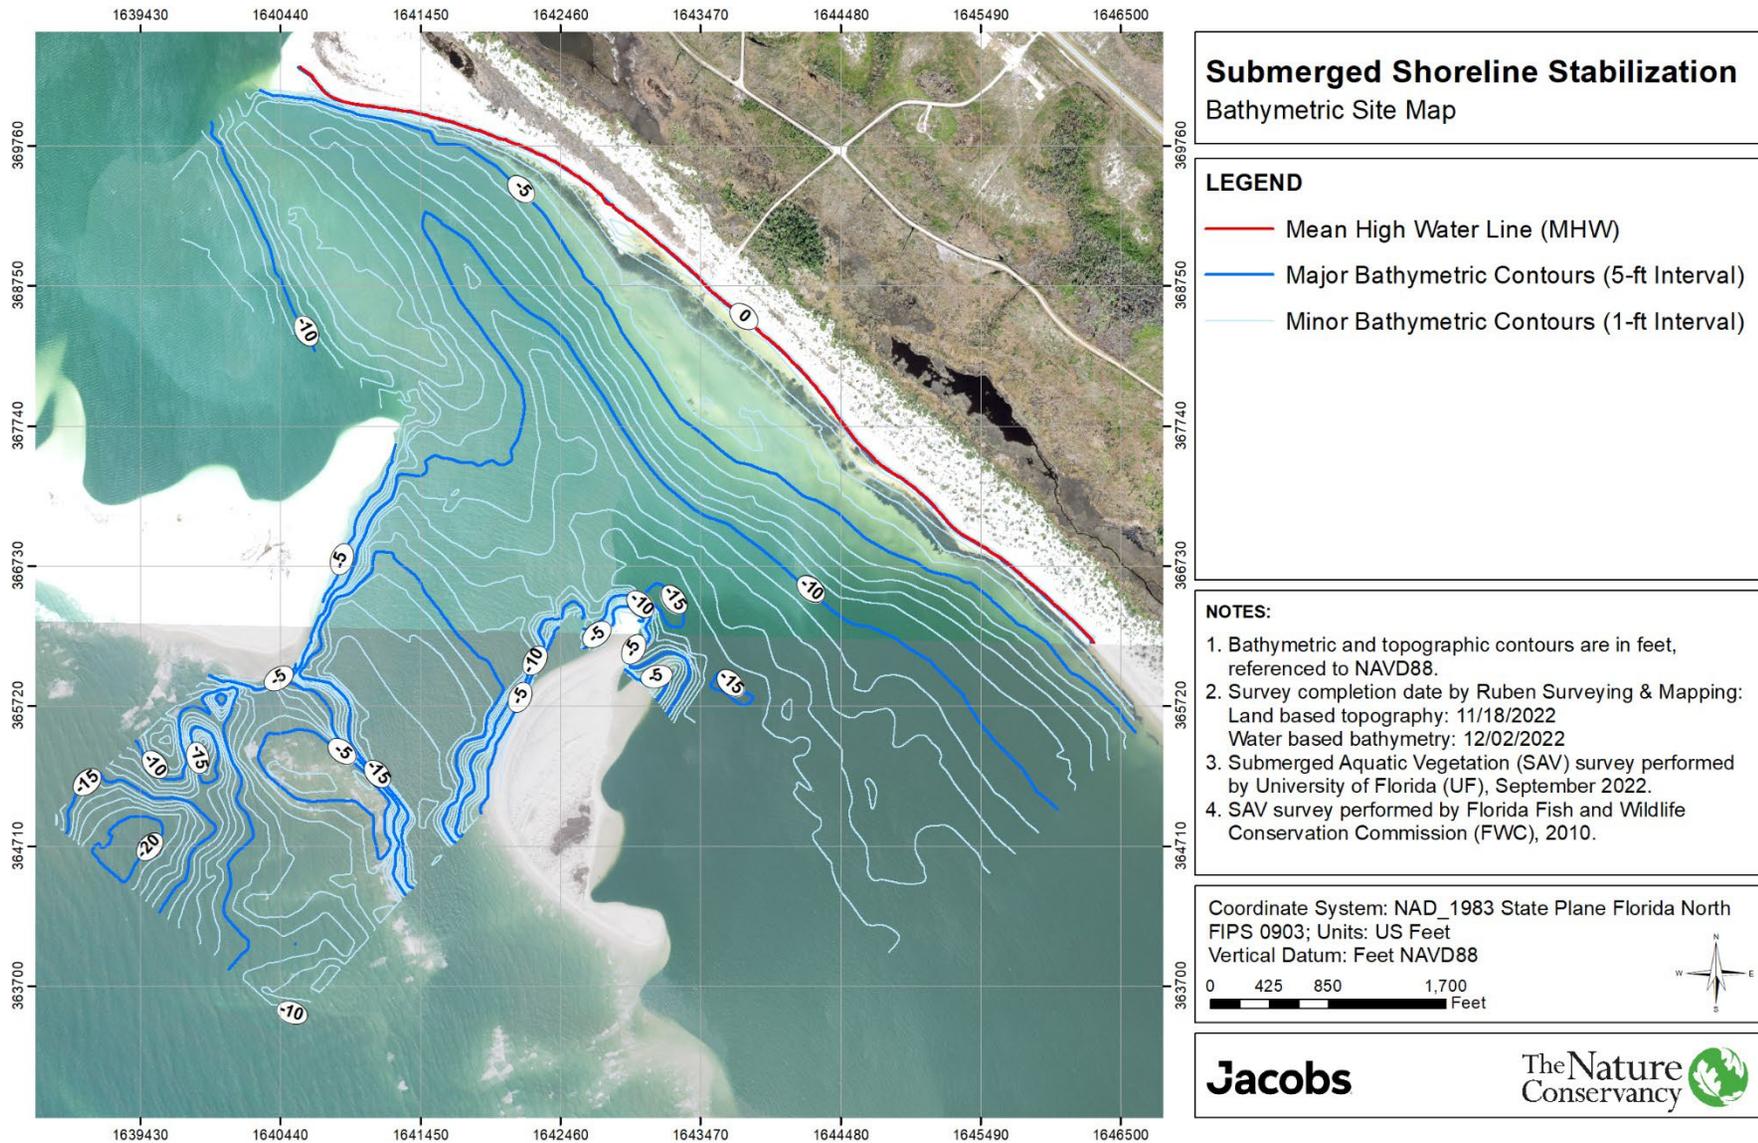
Figure 3-1. Site Bathymetry

The bathymetry in St. Andrew Sound in the project area should be considered to be dynamic, and the survey conducted in 2022 represents the conditions at the time of the survey. The morphology of a tidal inlet results from a complex response to tidal hydraulics of the system, wave energy characteristics, sediment supply, and the historical pattern of the inlet evolution. It is unclear how stable the inlet is currently; however, it is likely that bathymetric changes do occur regularly over time as a result of sediment over-wash into St. Andrew Sound during significant storms and sediment transport into and out of the inlet due to the action of tides and waves.

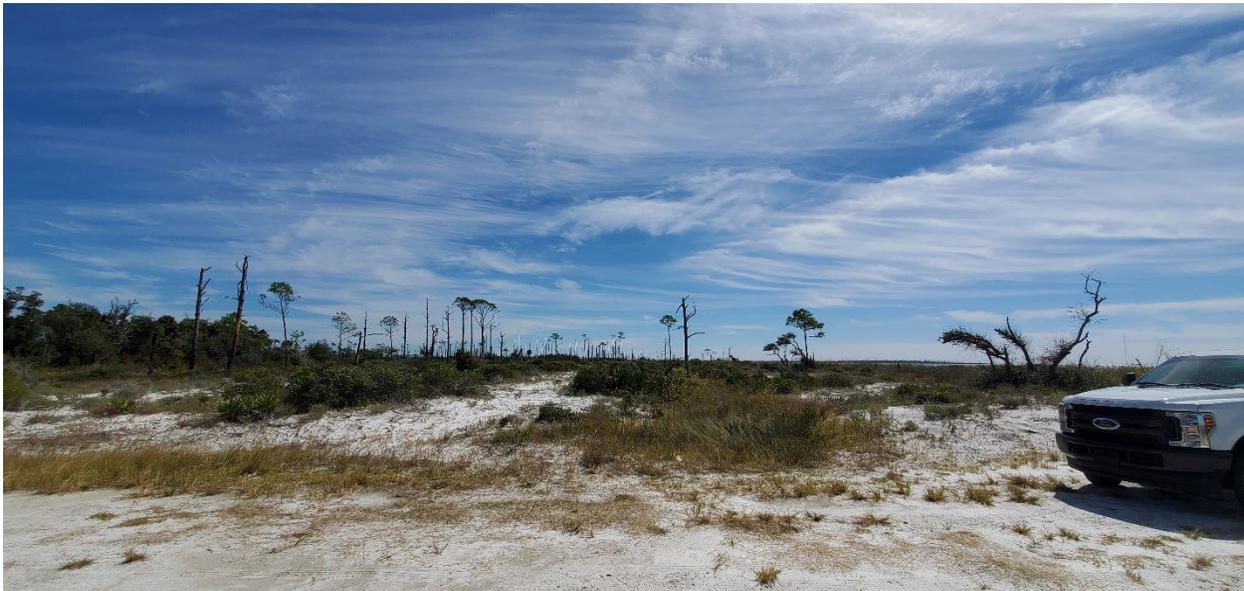
Figure 3-2. Onshore Part of the Project Site, October 2022

Figure 3-2 and **Figure 3-3** show photographs taken by Jacobs at the Submerged Shoreline Stabilization site during a site visit in October 2022. **Figure 3-2** was taken toward the east, showing the conditions of the site facing inland. **Figure 3-3** presents a view down the beach toward the northwest and shows two “ghost trees” with exposed roots systems, as well as a number of stumps further down the shoreline, which gives an indication of the historical recession of the shoreline in this area.

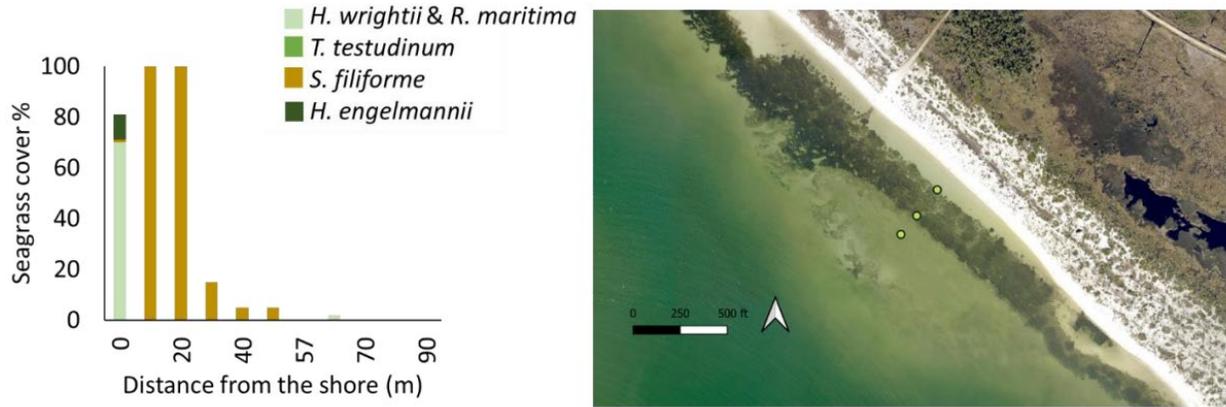
Figure 3-4. Seagrass Percent Cover Along the Survey Transect

During the survey, UF also recorded the various existing seagrass types and their percent cover along one transect at the Submerged Shoreline Stabilization project site. The location of the transect is illustrated on the right side of **Figure 3-4**. On the left side of **Figure 3-4**, the percent cover is shown over the distance from the shore. The distribution on **Figure 3-4** includes *H. wrightii*, *T. testudinum*, *S. filiforme*, and *H. engelmannii*, which are the most common types of seagrass noted at the project site.

"This seagrass meadow had differentiated areas with different seagrass species. The first meters were dominated by *H. wrightii* (~ 80%) and sporadic *S. filiforme* and *H. engelmannii*. The remaining of the transect was dominated by dense *S. filiforme* (100% cover) which started to be grazed from 30 m offshore until the end of the meadow. *T. testudinum* was observed in the meadow but was not present along the surveyed transect. Macroalgae cover was low (15% in one quadrat) and consisted of *Hypnea* spp. Other organisms such as sponges, tubeworms, clams, pen shells, tunicates, sand dollars, sea urchins, blue crabs and mussels were observed within the seagrass meadow. Epiphyte load was clean to light. The most dominant epiphyte were filamentous brown algae and

Bittium spp. (small snails). Seagrass shoot length varied between species. *H. wrightii* was longer in the Gulf side than in the Bay side, being ~ 30 cm long. *S. filiforme* was ~ 50 cm long when not grazed and ~ 4 cm when grazed."

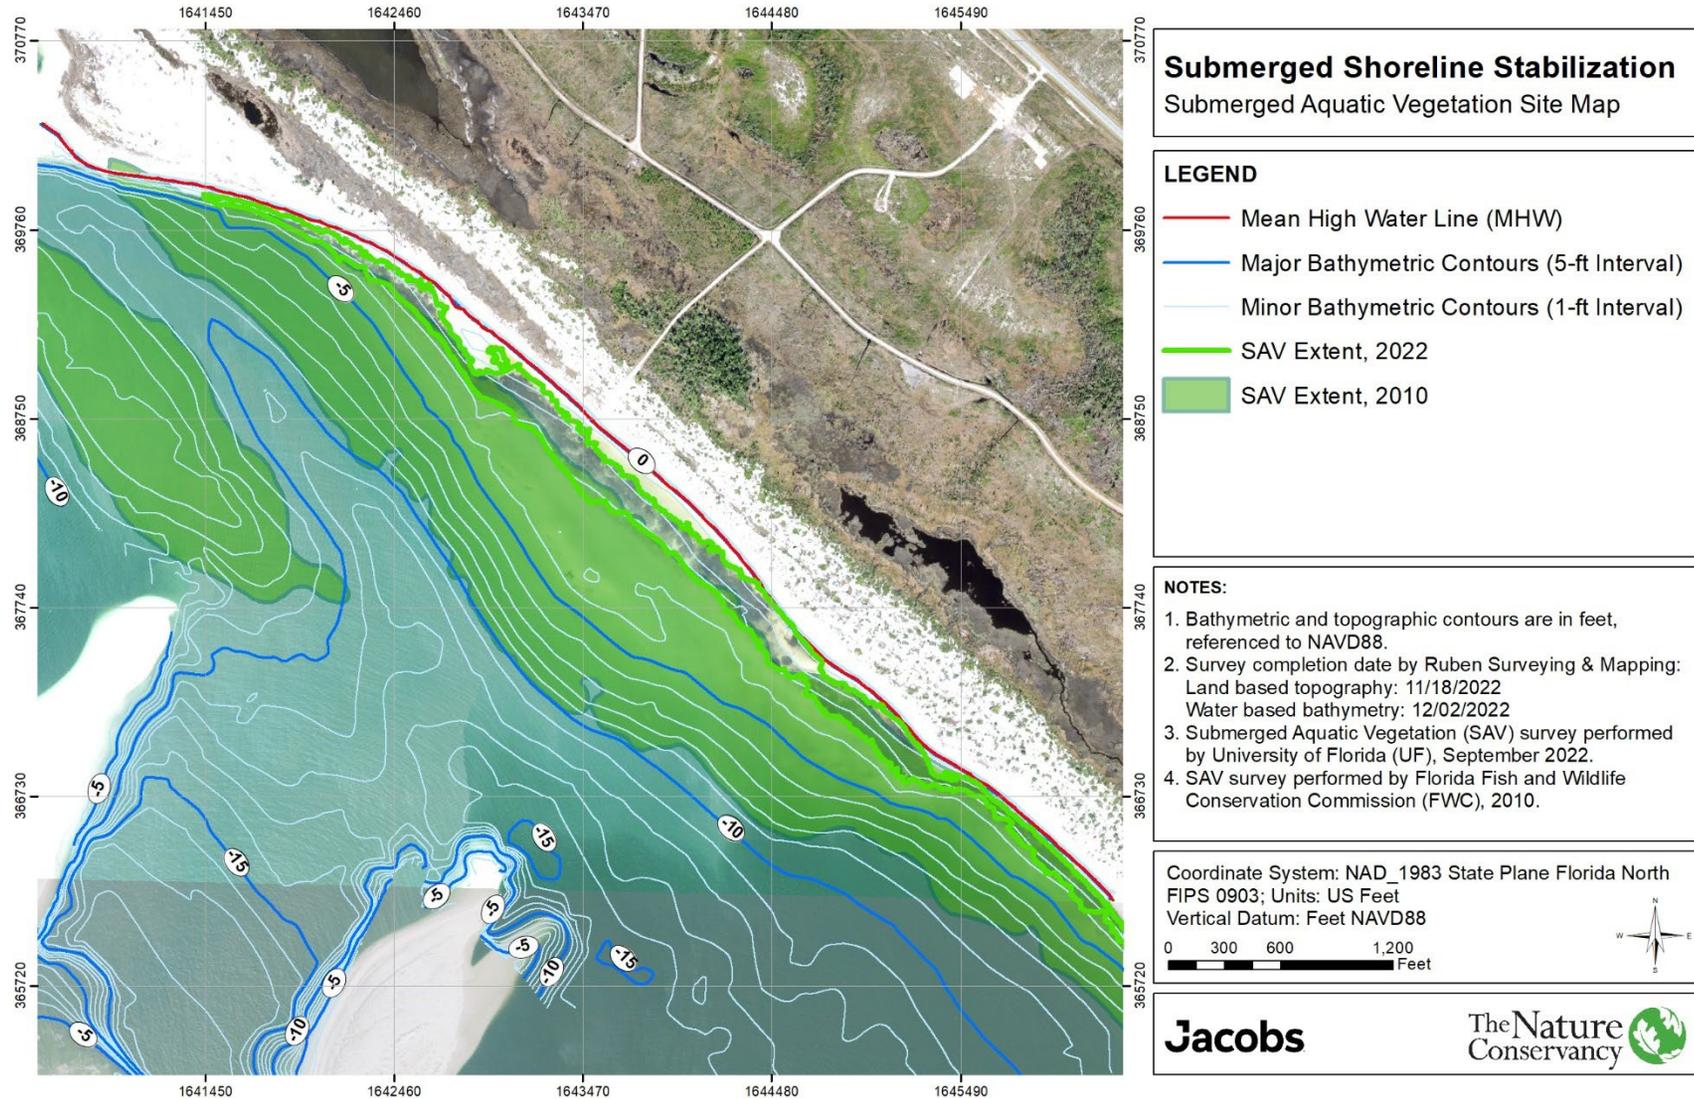
Figure 3-5. SAV Extent Based on UF Survey and FWC Database Extent for the Project Site

SAV, specifically seagrass, is a principal physical constraint associated with the Submerged Shoreline Stabilization site. Import and placement of material is limited to areas beyond the seaward limits of existing seagrass footprint.

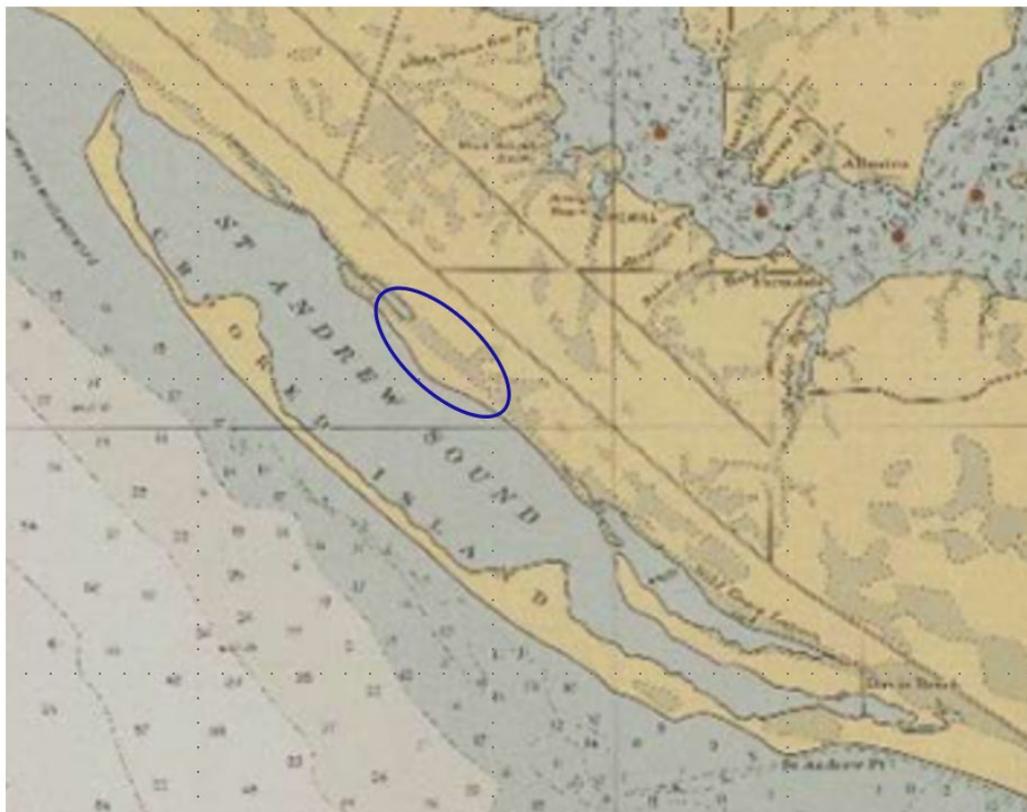
Figure 3-6. Ness Coastal Headland, Ness at Buck Beach from 1940 Nautical Chart

Before 1973, St. Andrew Sound was fronted by Crooked Island, a single contiguous barrier island that sheltered Buck Beach from waves from the Gulf of Mexico. The shoreline in the project area had a small promontory, or ness,¹ along approximately 4,000 feet of the shoreline and extending approximately 800 feet into St. Andrew Sound (refer to **Figure 3-6** from a 1940 nautical chart). No topographical data, other than low-resolution aerial photos and the nautical chart shown on **Figure 3-6**, are available to estimate the initial size of this ness.

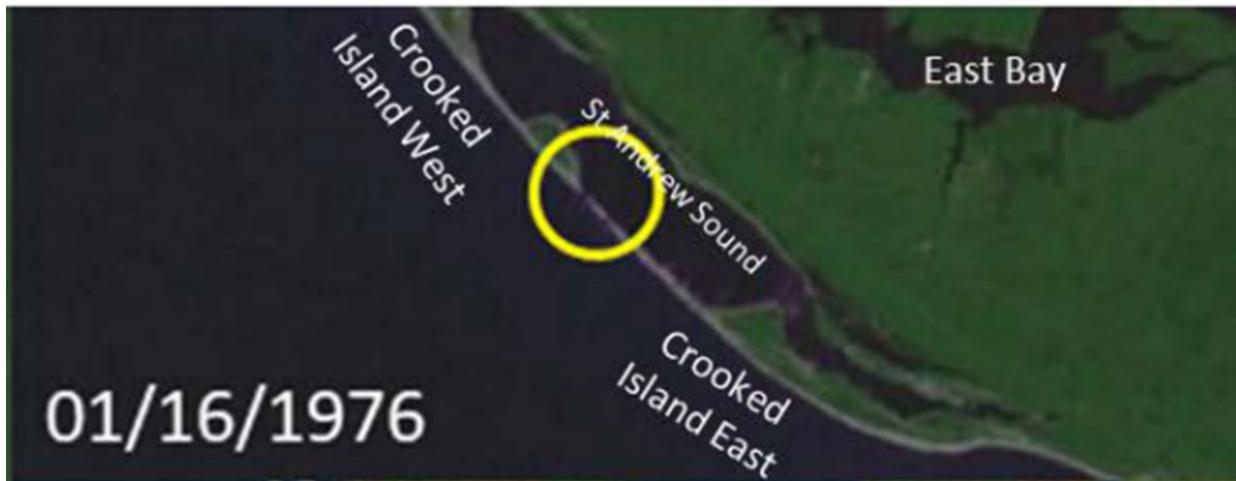
Figure 3-7. Initial Breach into St. Andrew Sound Near Buck Beach

Hurricane Eloise made landfall 10 miles northwest of the site as a Category 3 hurricane in 1975. Evidence of breaches splitting Crooked Island into two distinct islands following Hurricane Eloise can be seen in the 1976 aerial photograph shown on **Figure 3-7**.

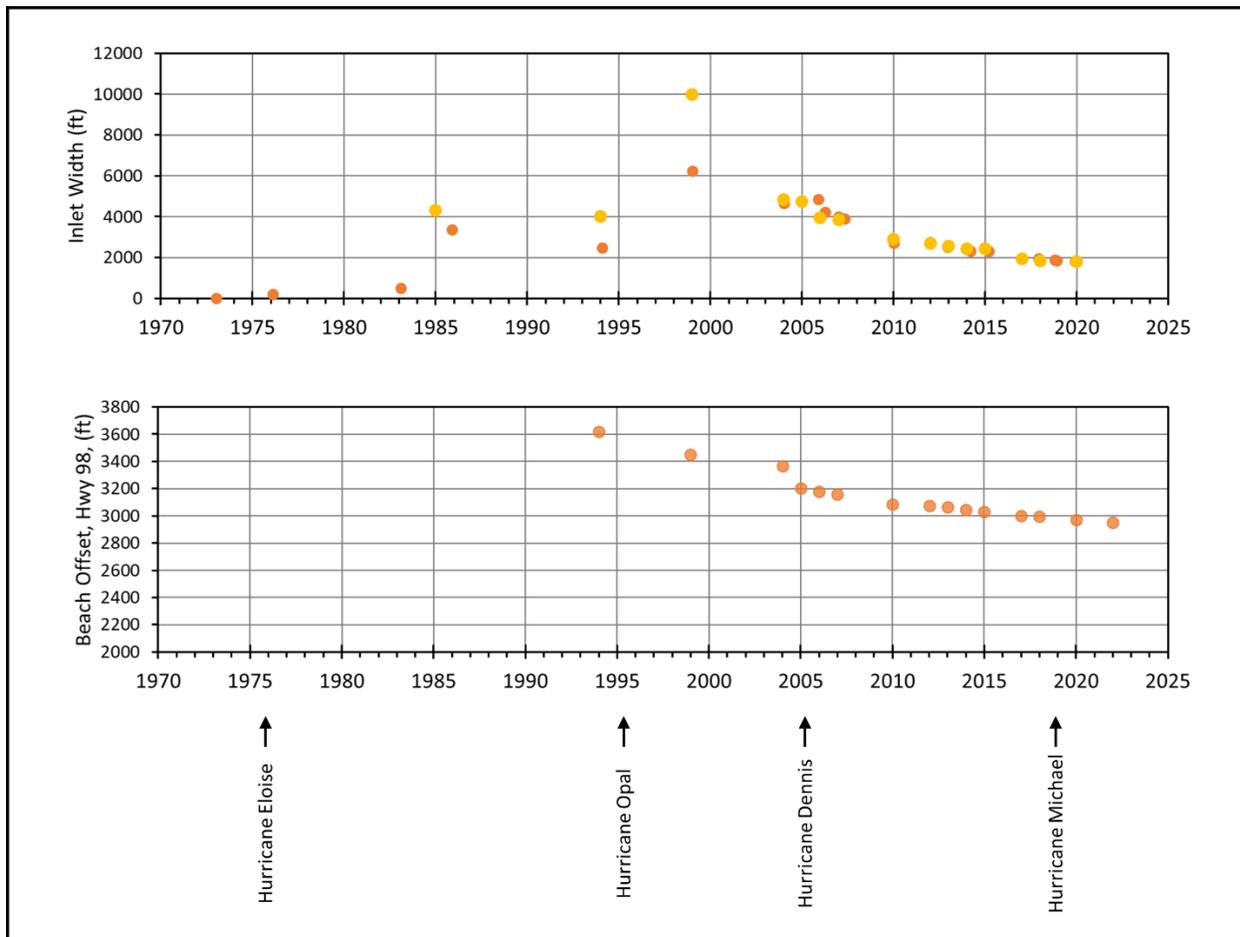
Figure 3-8. Inlet Width and Shoreline Position with Time

Figure 3-8 shows the change in inlet width over time and the distance between U.S. Highway 98 (US-98) and the shoreline at the location of the ness based on information from open source aerial images.

Figure 3-8 shows that the period from 1976 to 1999 saw an expansion of the inlet, followed by a relatively consistent narrowing to the present day. Figure 3-8 also shows erosion rates that generally track the narrowing of the inlet, with higher rates observed when the inlet was the widest and tapering off as the inlet narrowed (and the shoreline began to straighten).

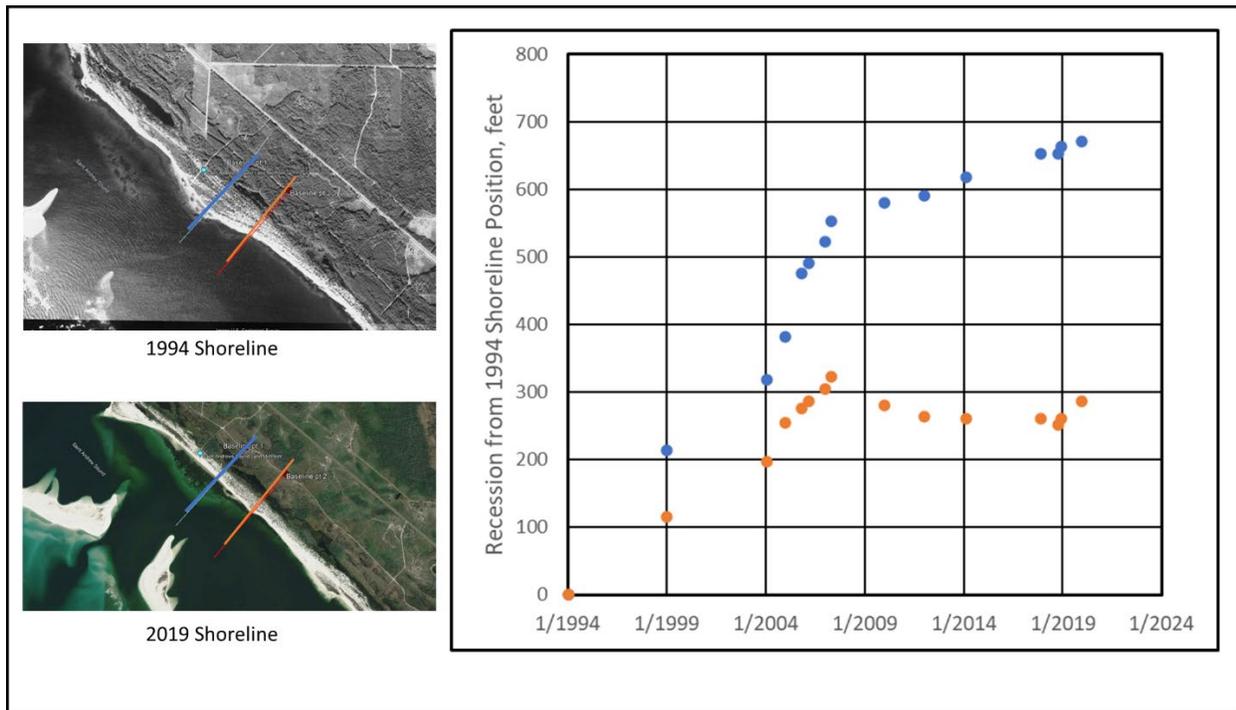
Figure 3-9. Historical Shoreline Position at Buck Beach

Figure 3-9 shows the recession of the shoreline (as indicated by the waterline on aerial imagery) for two transects from 1994 through 2020 relative to the shoreline position in 1994. Figure 3-9 shows the most rapid recession of the shoreline prior to 2007, with a recession of approximately 40 feet per year along the blue transect and 24 feet per year along the orange transect, based on linear interpolation of the data through 2007. The erosion rates subsequently decreased, with erosion along the blue transect reduced to approximately 9 feet per year and the shoreline even accreting along the orange transect (up to 3 feet of accretion per year) as the mouth of the inlet narrowed such that the shoreline at the orange transect was no longer positioned opposite the inlet opening.

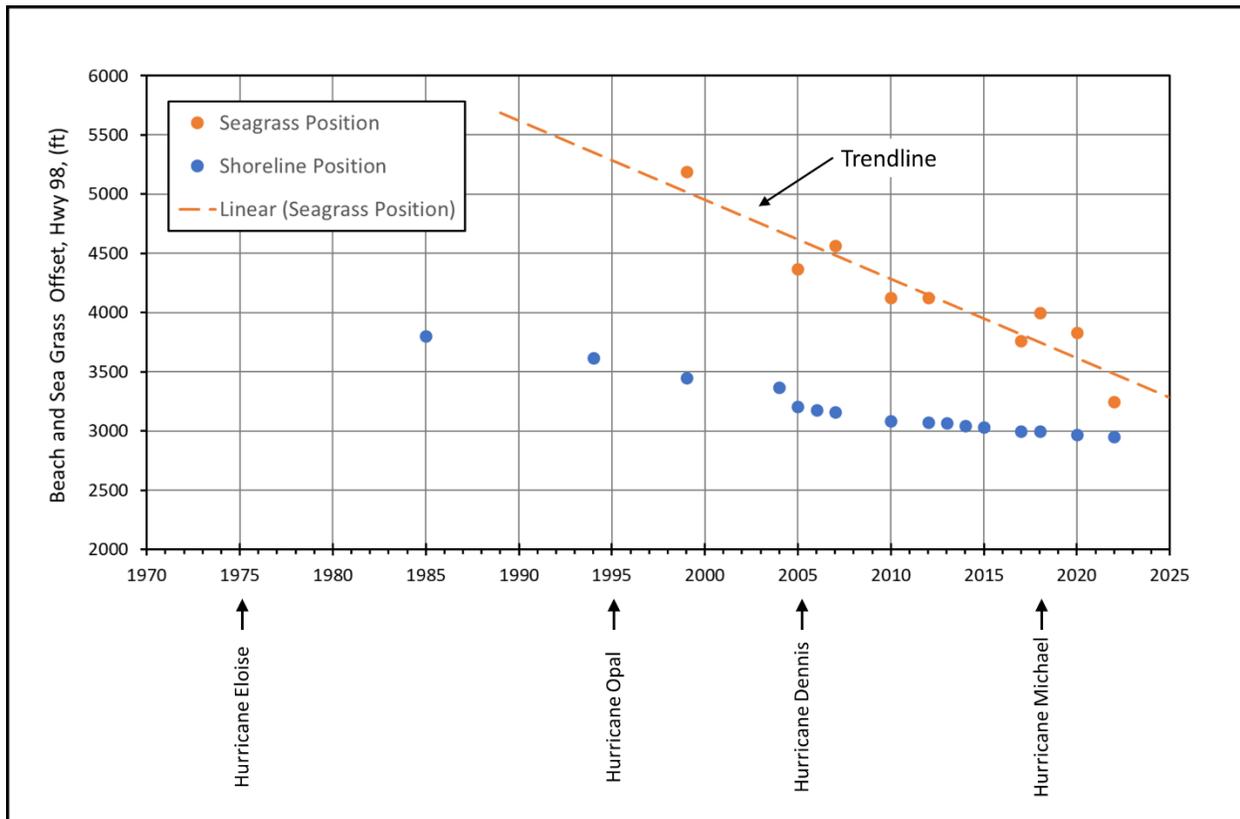
Figure 3-10. Position of Offshore Extent of Buck Beach SAV Beds Compared with Shoreline Position

Changes in SAV coverage can be due to grazing (for example, by sea urchins), wasting (disease), erosion, or deposition (which could result in burial of SAV). Observed changes are likely due to a combination of these factors. The trend seen in the data for the position of the seaward extent of SAV suggests ongoing erosion is a contributor and that the submerged ness is continuing to recede with the increasing water depths over this feature, limiting the area on which the SAV can establish.

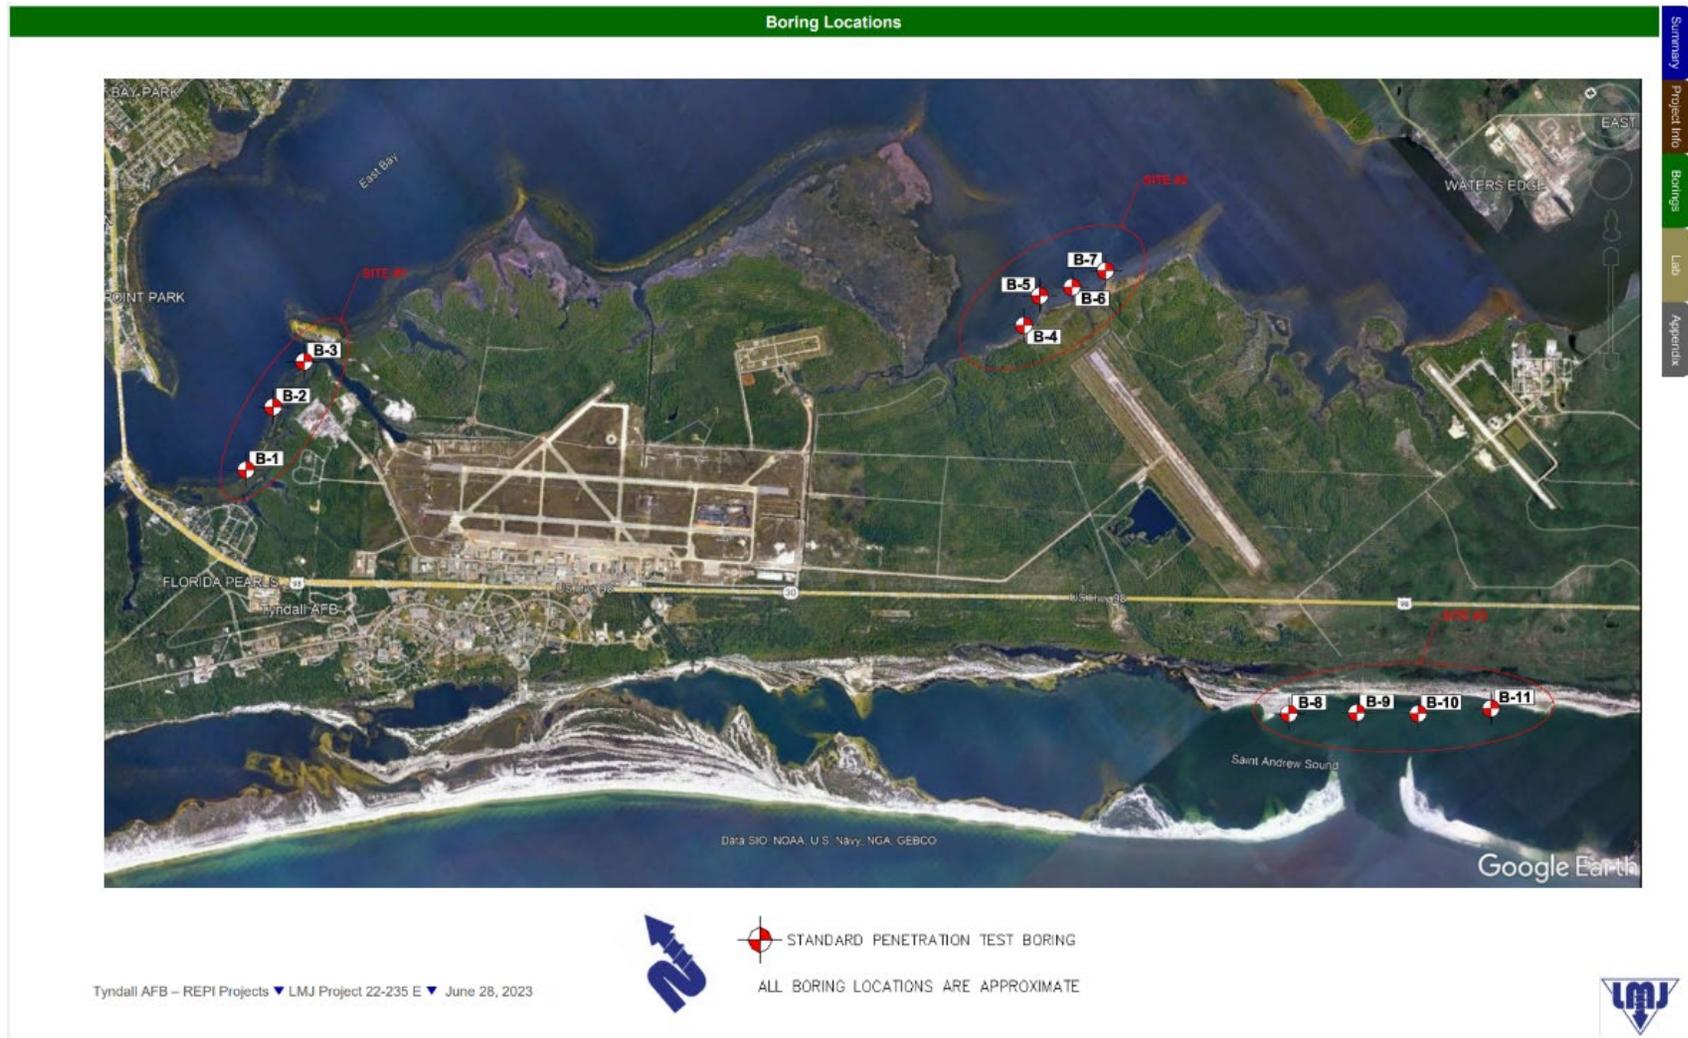
Figure 3-11. Geotechnical Investigation Boring Locations

For the Submerged Shoreline Stabilization, the borings generally showed tan, brown, and gray sand soils to the bottom of the borings at roughly 9.5 feet below the mudline at the time of drilling. At boring B-9, a layer of brown slightly silty sand with trace clay pockets at roughly 2.5 to 6 feet was encountered below the mudline. Overall, the soils in these borings were mostly loose with occasional very loose and medium dense areas to the bottom of the borings at roughly 9.5 feet below the mudline. The mudline at these locations was roughly 6.5 to 9 feet below the surface of the water at the time of drilling (LMJ 2023).

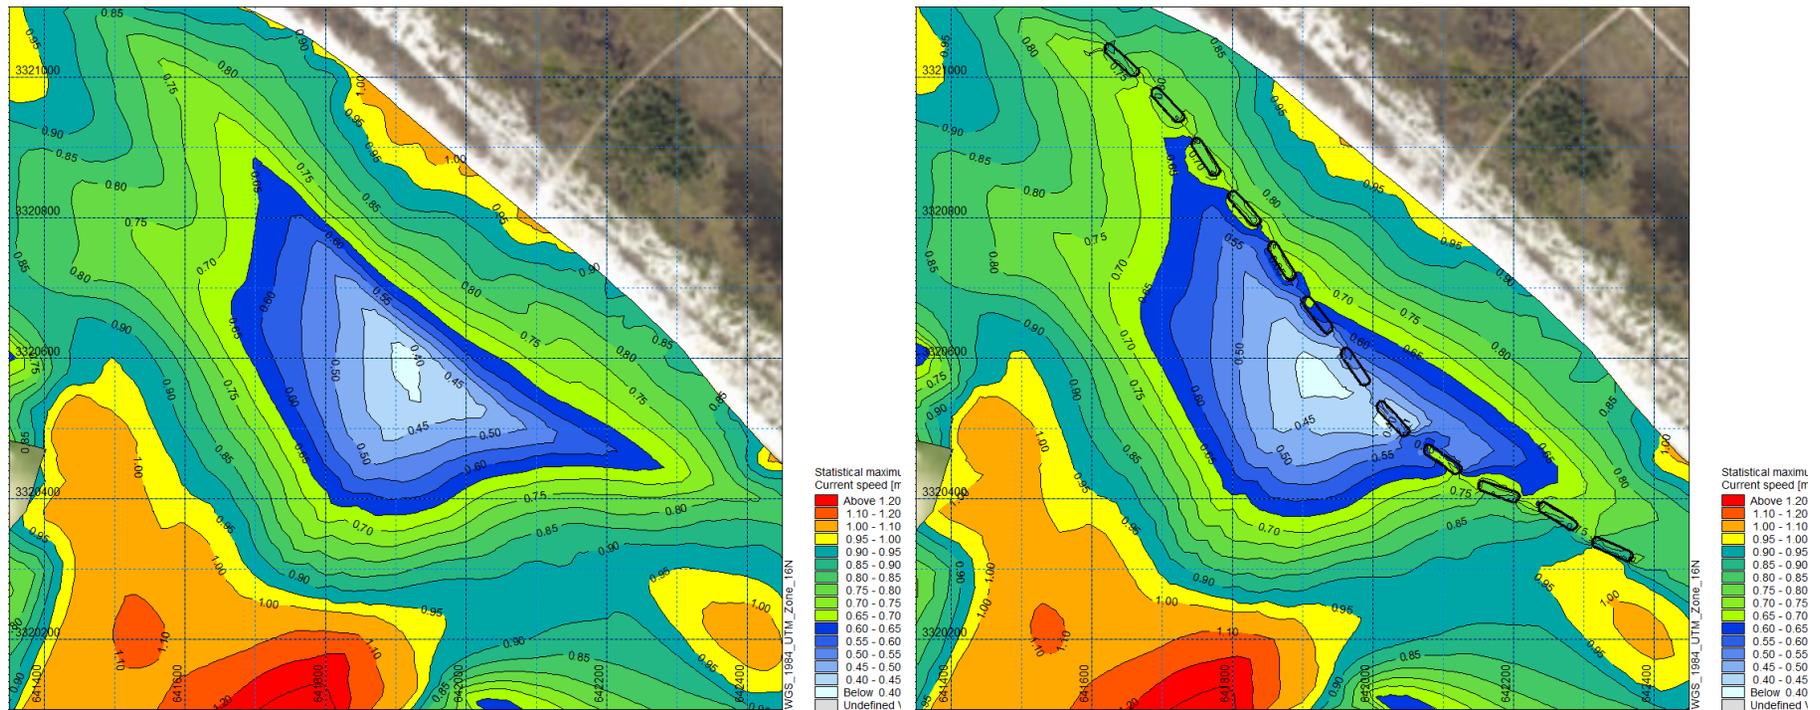
Figure 3-14. Maximum Current Speeds for the 50-year Extreme Event under Future (2075) Conditions without and with Structures in place

The modeling results under future conditions (2075) are shown in **Figure 3-14**, where the figure on the left represents the conditions without structures in place and the figure on the right the conditions with the structural layout in place to investigate the effects of the structure on current patterns.

For the design, a peak current of 2.6 feet per second (0.8 meter per second) was conservatively considered for the scour and stability analysis of the Submerged Shoreline Stabilization. This value represented the maximum current speed near the proposed structures (**Figure 3-14**).

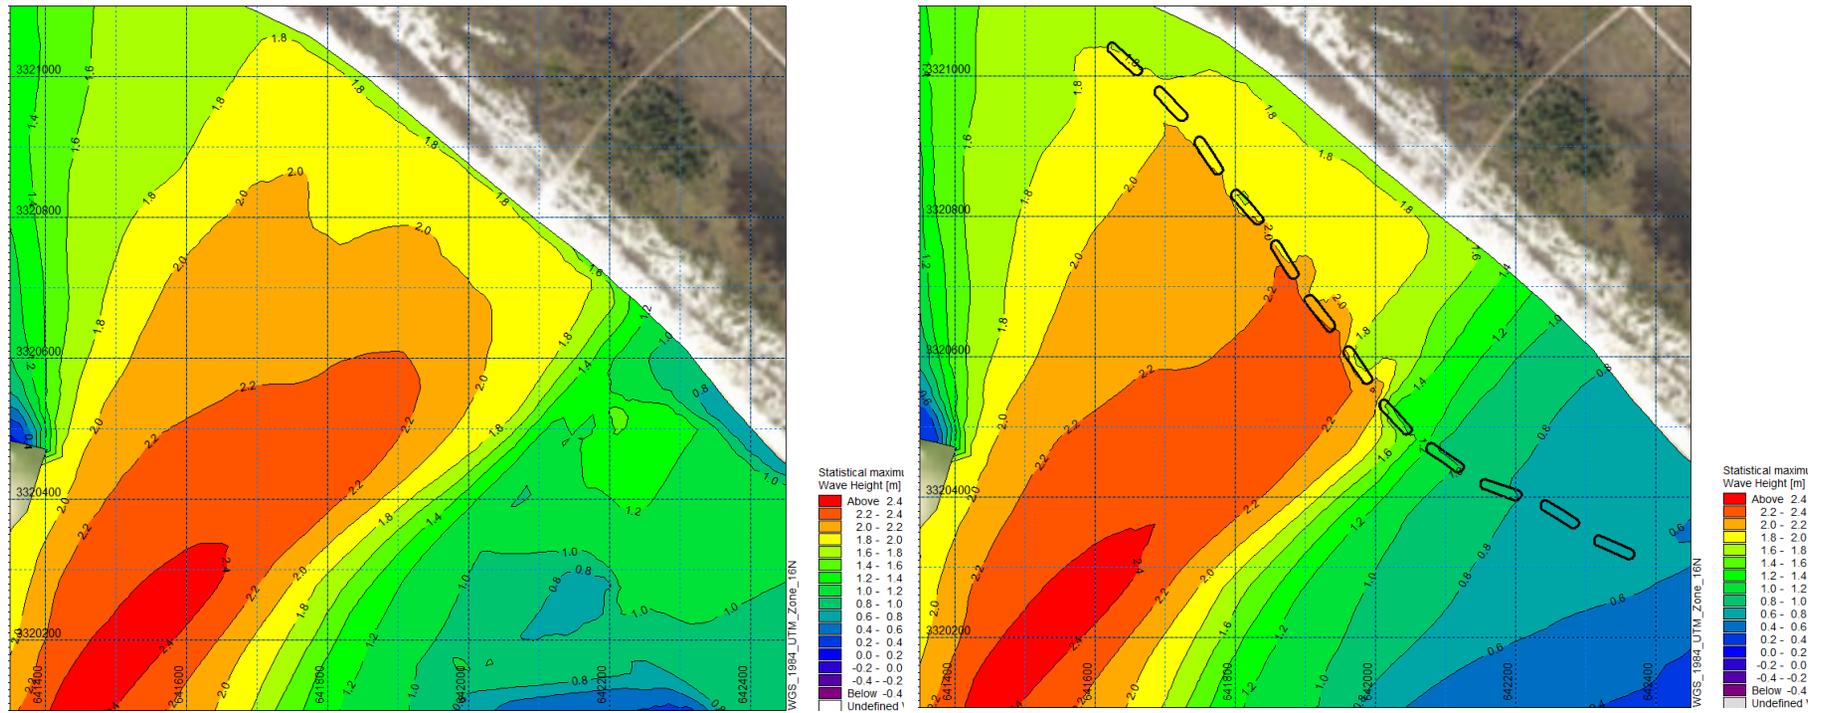
Figure 3-15. Maximum Significant Wave Heights for the 50-year Extreme Event under Future (2075) Conditions without and with Structures in place

The modeling results under future conditions (2075) are shown in **Figure 3-15**, where the figure on the left represents the conditions without structures in place and the figure on the right the conditions with the preferred structural layout in place to investigate the effects of the structure on wave patterns.

Generally, waves enter St. Andrew Sound during the extreme event from the Gulf by propagating through the inlet and washing over the submerged barrier islands. Waves inside the Sound are limited by wave breaking both on the shoal in front of the inlet as well as over the submerged islands, reducing wave heights considerably compared to waves approaching the site from the Gulf.

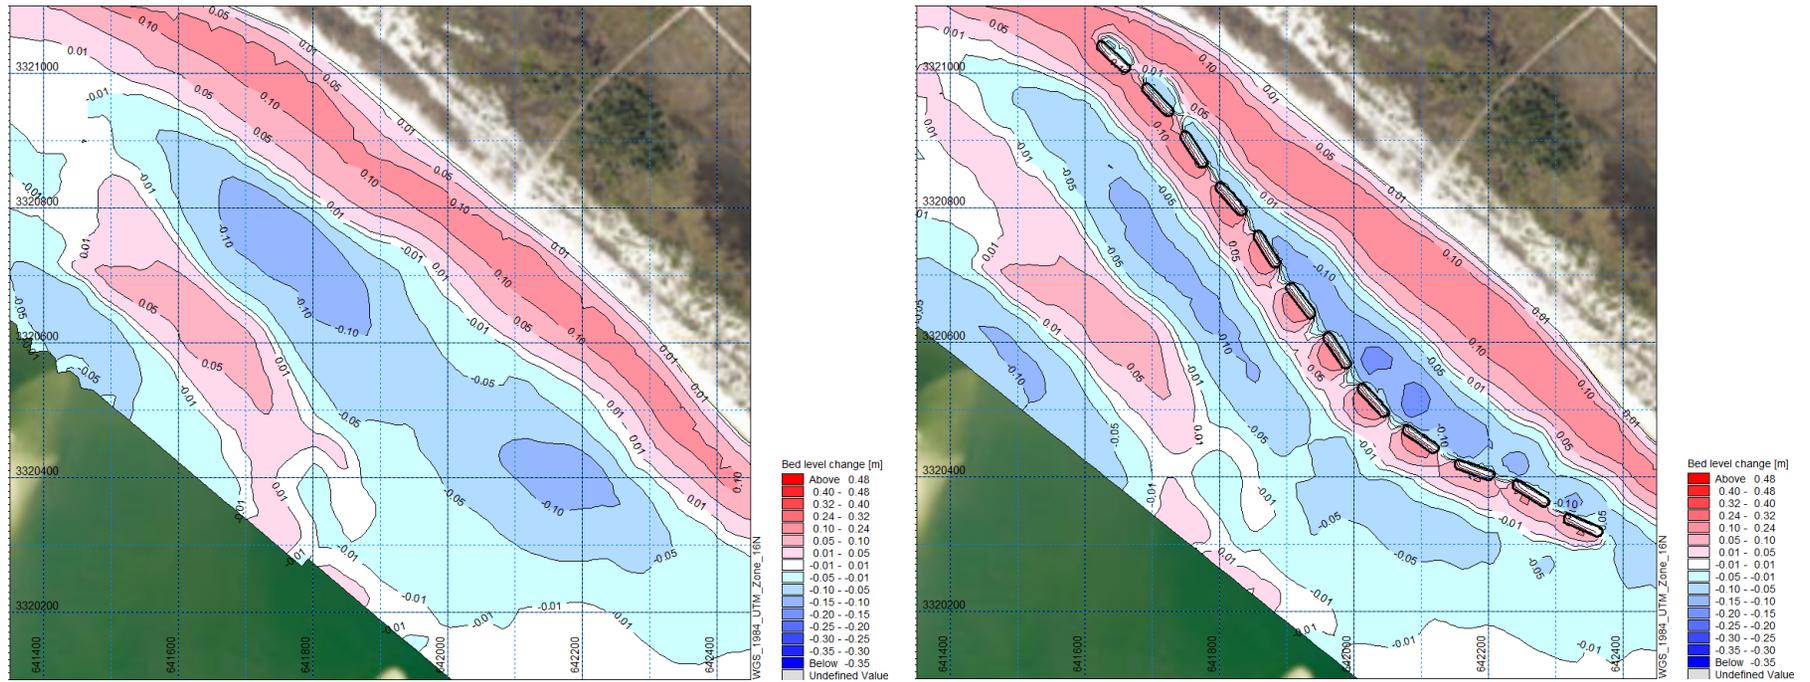
Figure 3-16. Modeled Distribution of Annual Sedimentation Rate without and with Structures in place

With the structures in place, the model predicted an overall average sedimentation rate for the area behind the submerged breakwaters of 0.09 m/year. This compares with rates of SLR based on the NOAA 2017 intermediate-high scenario of 0.012 m/year at the start of the project and a rate of 0.024 m/year at the end of the 50-year project, suggesting that sedimentation in the area between the breakwaters and the structures could exceed the changes in sea level, reducing the water depth and reducing the potential for increased recession of the shoreline as a result of SLR.

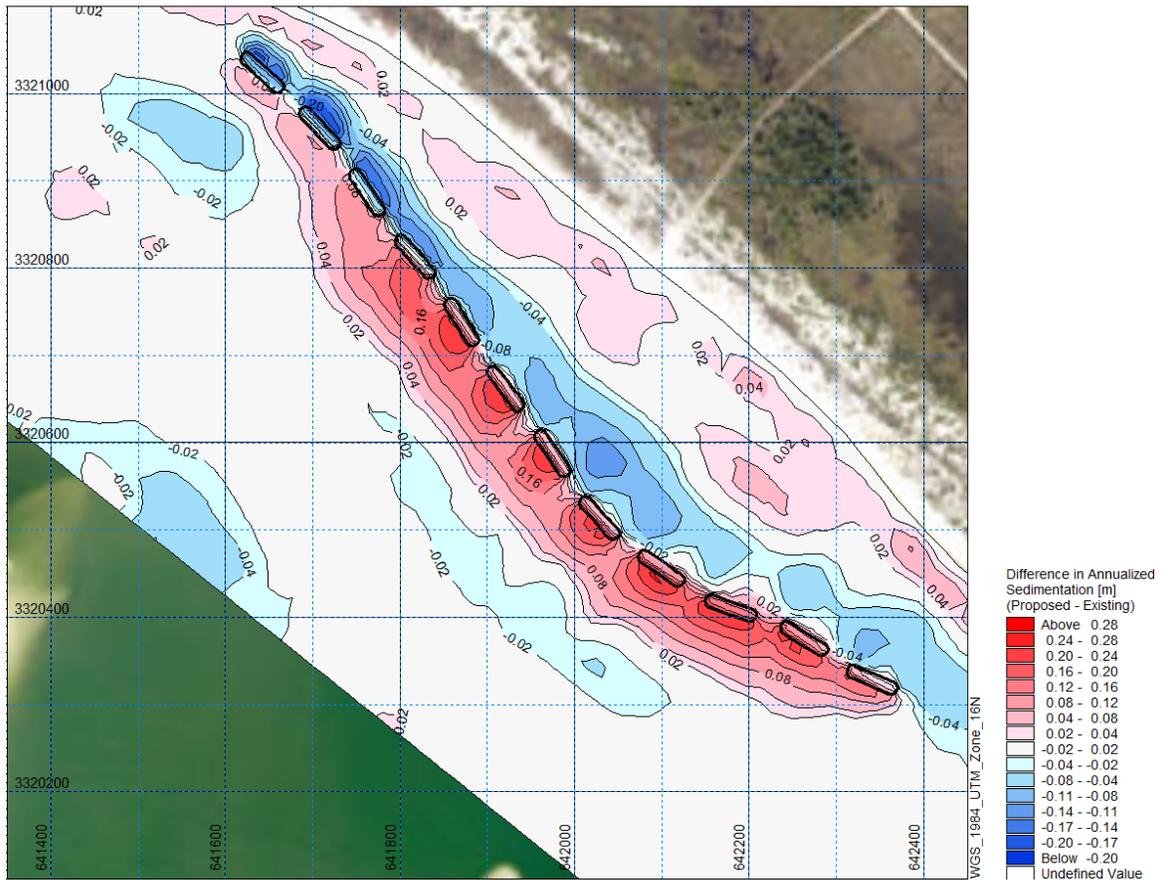
Figure 3-17. Difference Plot of the Modeled Distribution of Annual Sedimentation Rate between Preferred Layout and without Structures in place

Note: Red color denotes increased sedimentation; blue denotes increased erosion relative to the existing conditions.

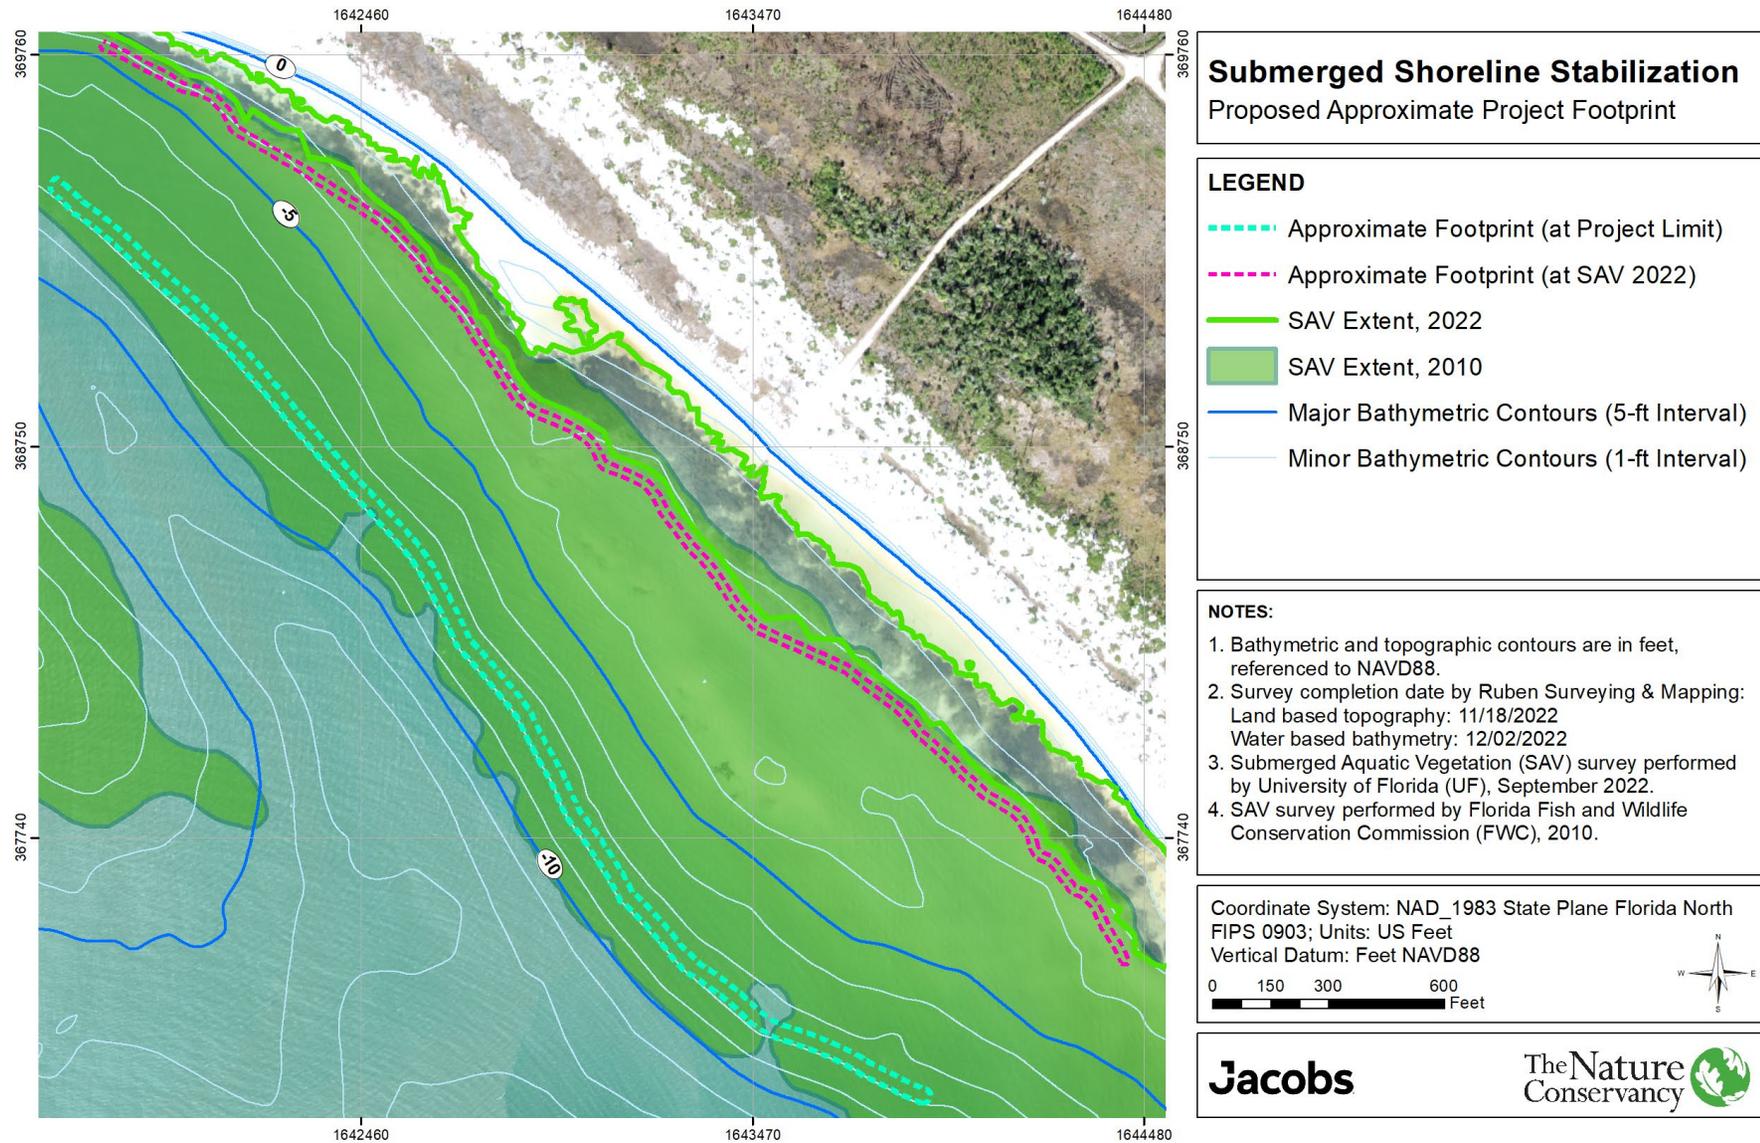
Figure 4-1. Proposed Approximate Project Footprint

The approximate footprint of the Submerged Shoreline Stabilization pilot project, at the preliminary design stage, is shown on **Figure 4-1**. The total footprint was intended to cover a length of 3,500 feet (longer if gaps are included) and would be oriented parallel to the shoreline. Two alternative footprints are considered: a deep-water location and a shallow-water location. The preliminary layout structures were designed with the intent to be located in deep water and constructed right at the offshore edge of the defined project area following the -8-foot contour, which will place the structure along the outer edge of the 2010 seagrass extent. The structures located in shallow water would have been constructed no closer than 25 feet from the seaward extent of seagrass based on mapping performed by UF (2022b) to prevent negative impacts to the seagrass during construction. The footprint of the preliminary layout structures of the deep- and shallow-water options is shown on **Figure 4-1**.

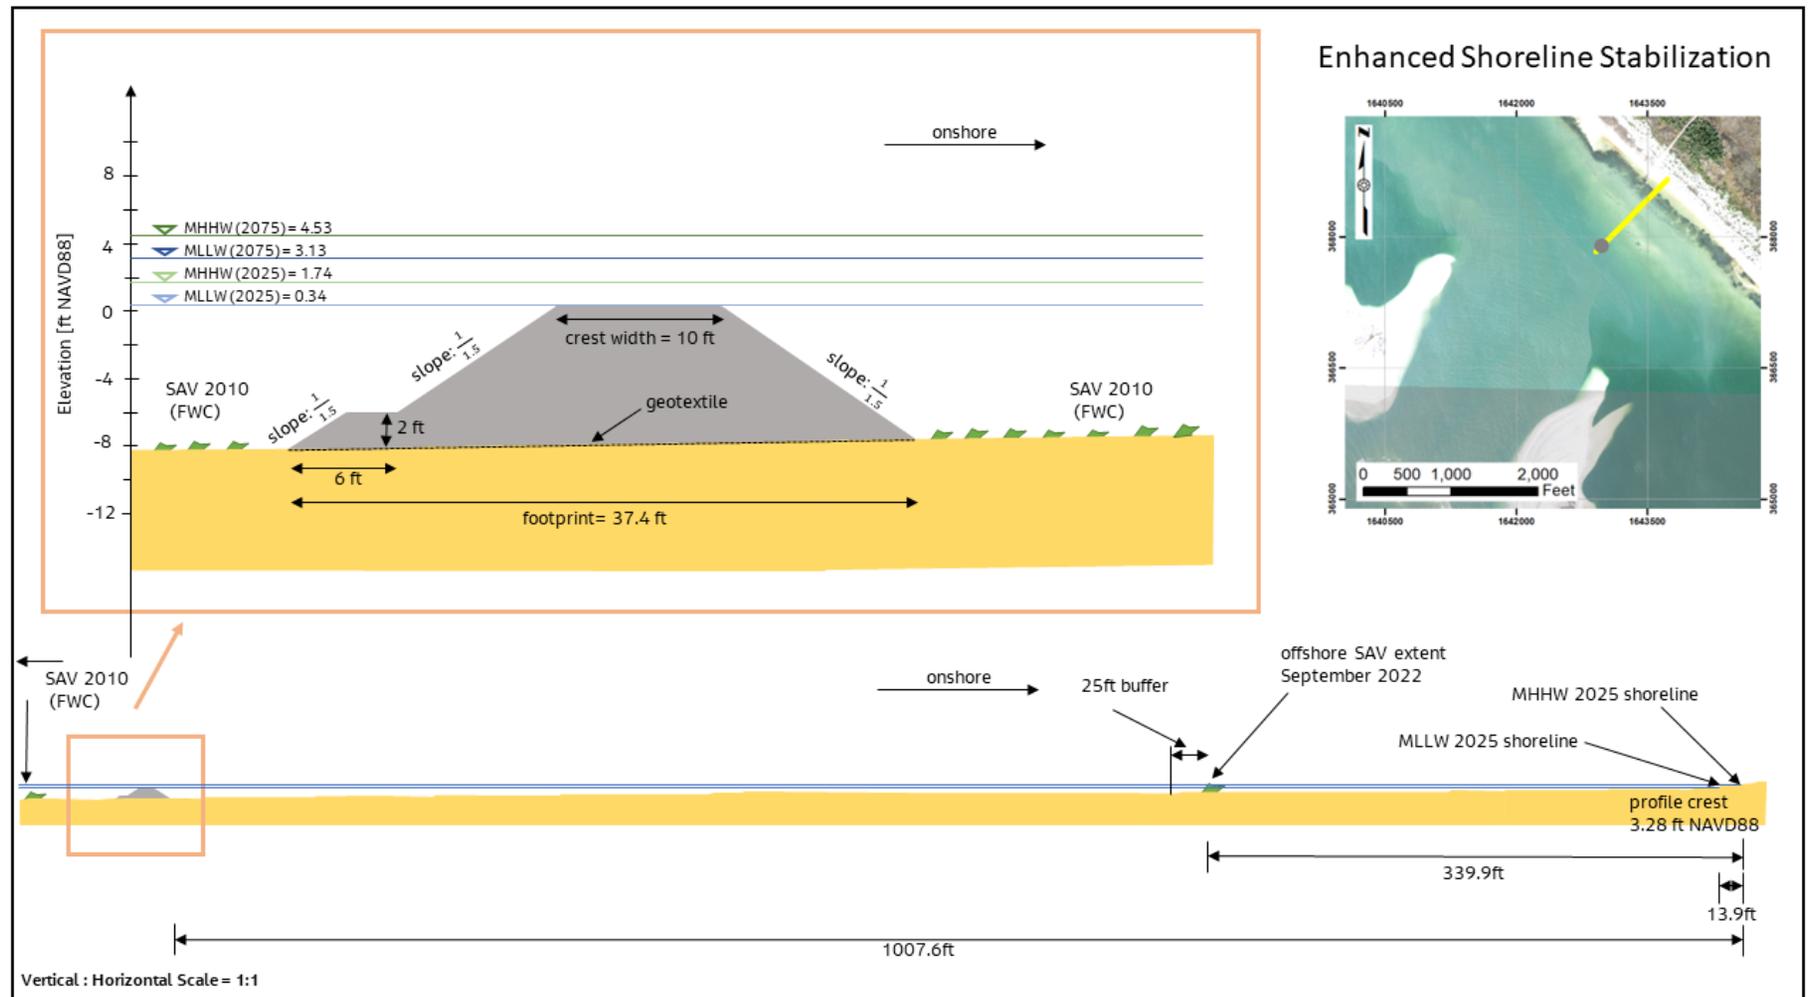
Figure 4-2. Submerged Rubble Mound Breakwater with Toe with a Crest Width of 10 feet and a Crest Elevation at MLLW 2025

The rubble mound structures can be modified in the future in response to SLR by adding more stone or armor units to the face and top of the breakwater.
