Tyndall Pilot Project, Submerged Shoreline Stabilization: 60% Basis of Design Report

The Nature Conservancy

Tyndall Pilot Project Design and Permitting

July 24, 2024

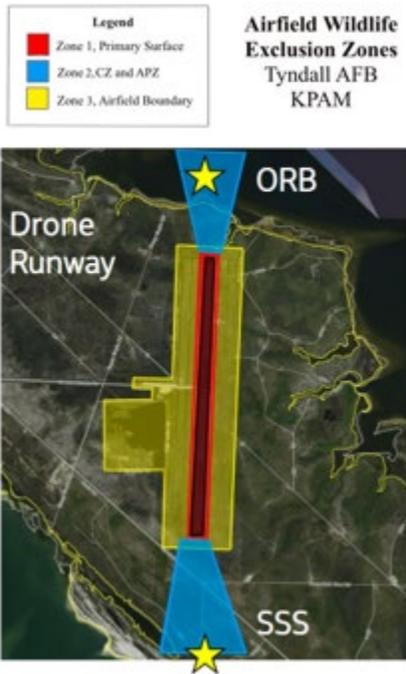
Figure 4-6. Runway and Flightline Operational Constraints (BASH)

During the meeting, the BASH group highlighted that the project alternatives need to be further reviewed due to risks that emerged structure segments could attract birds and, therefore, endanger the aircraft traffic at the Base. On July 6, 2023, a summary of wave attenuation, exposed area, and duration of exposure for all nine alternatives for the three pilot sites was presented during a follow-up meeting with BASH. While the preference from a coastal resilience and shoreline protection viewpoint is for options that offer the highest degree of wave attenuation, BASH highlighted their preference for submerged alternatives over emergent structures. BASH noted that emergent structures present an increased risk of bird attraction that can endanger air traffic due to exposed area and duration of exposure. The Submerged Shoreline Stabilization project is adjacent to airfield Wildlife Exclusion Zones as defined by BASH. The exclusion zones are shown on **Figure 4-6**.

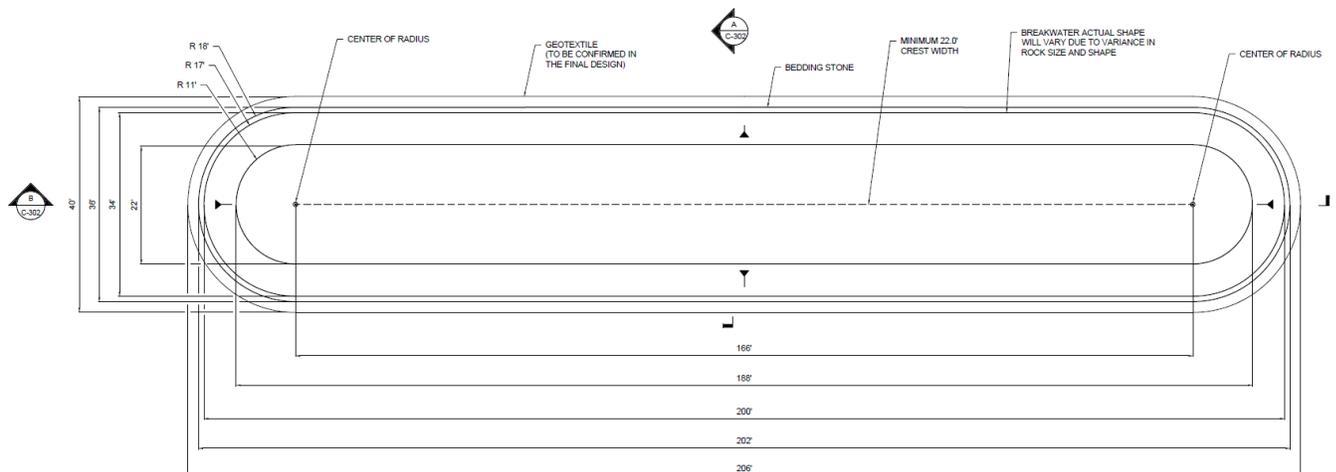
Figure 5-1. Typical Submerged Shoreline Stabilization Plan View

The typical reef cross section and plan view are shown on **Figure 5-1** and **Figure 5-2**.
