## Phase 1 Design Plan

# “Scaling Up of Bamboo Stockade Experimental Treatment to Protect Seagrass Habitat in St. Andrew Sound”

East Bay Living Shoreline and Seagrass Project

RESTORE Act - Bay County

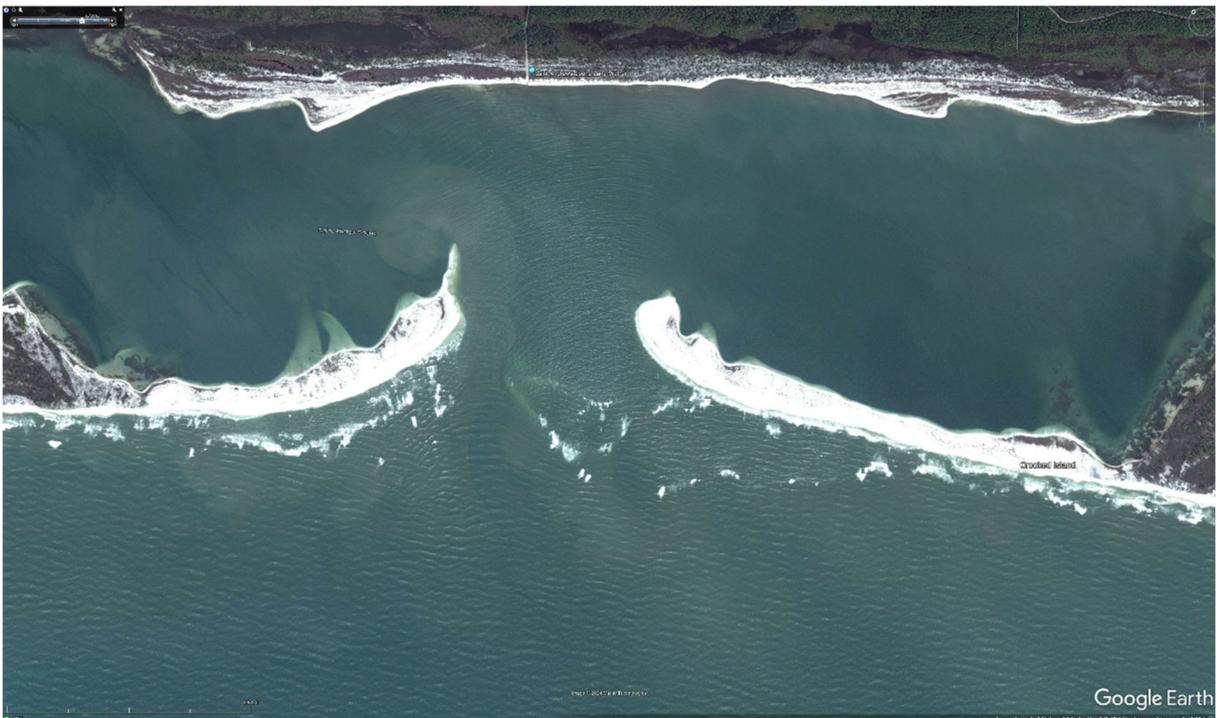
**Figure 2.** Satellite image from 2012 (Dec) showing wave diffraction through the inlet mouth with focusing of these waves at the center shoreline of Buck Beach while the eastern and western shorelines are sheltered from the wave energy.

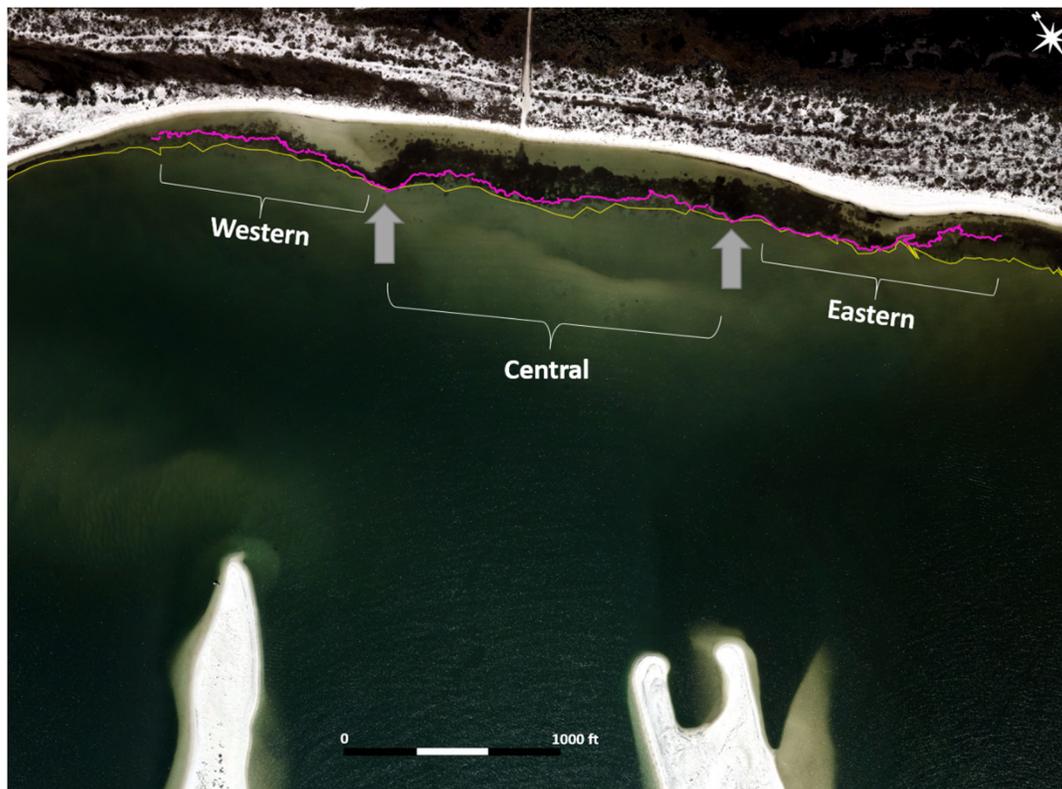
**Figure 3.** Seagrass extent mapped in 2022 by UF using RTK GPS via walking and snorkeling (yellow line) with 2024 extent mapped by NRL using DGPS and sidescan sonar (pink line). Basemap imagery is 2022 3 band satellite imagery (Landsat 8). Stable points are indicated by the grey arrows while regions of loss are denoted by brackets and rough compass direction in relation to the access road.

The seagrass meadow edge on the submerged shoreline feature has been retreating since Hurricane Michael hit the area in 2018. The seagrass meadow edge migrated inland from 2022 to 2024 with an average retreat of  $89 \text{ ft} \pm 38 \text{ ft st dev}$  (Fig. 3). Horizontal loss was most notable in the area immediate landward of the inlet while the edge appeared stable behind the barrier island spits but loss was observed eastward and westward of the stable regions. The largest change (143 ft) occurred at the eastern end of the survey area while the central meadow section directly behind the inlet and between the stable edge points averaged a loss of  $40 \text{ ft} \pm 17 \text{ ft st dev}$ . Overall, the seagrass meadow lost approximately 1.56 hectares ( $\pm 0.24$  hectares of uncertainty) between 2022 and 2024. Note the uncertainty value in the surface area calculation was derived from the maximum combined horizontal uncertainty of the methods used in 2024 (DGPS with sidescan sonar) and 2022 (RTK GPS via walking and snorkeling).

Changes in SAV coverage can be due to grazing (for example, by sea urchins), wasting (disease), erosion, or deposition (which could result in burial of SAV). Observed changes are likely due to a combination of these factors. The trend seen in the data for the position of the seaward extent of SAV, and cliffs observed *in situ* on the meadow edge, suggests ongoing erosion is a contributor, and that the submerged shoreline feature behind the inlet is continuing to recede and/or lose elevation, limiting the area on which the SAV can establish.

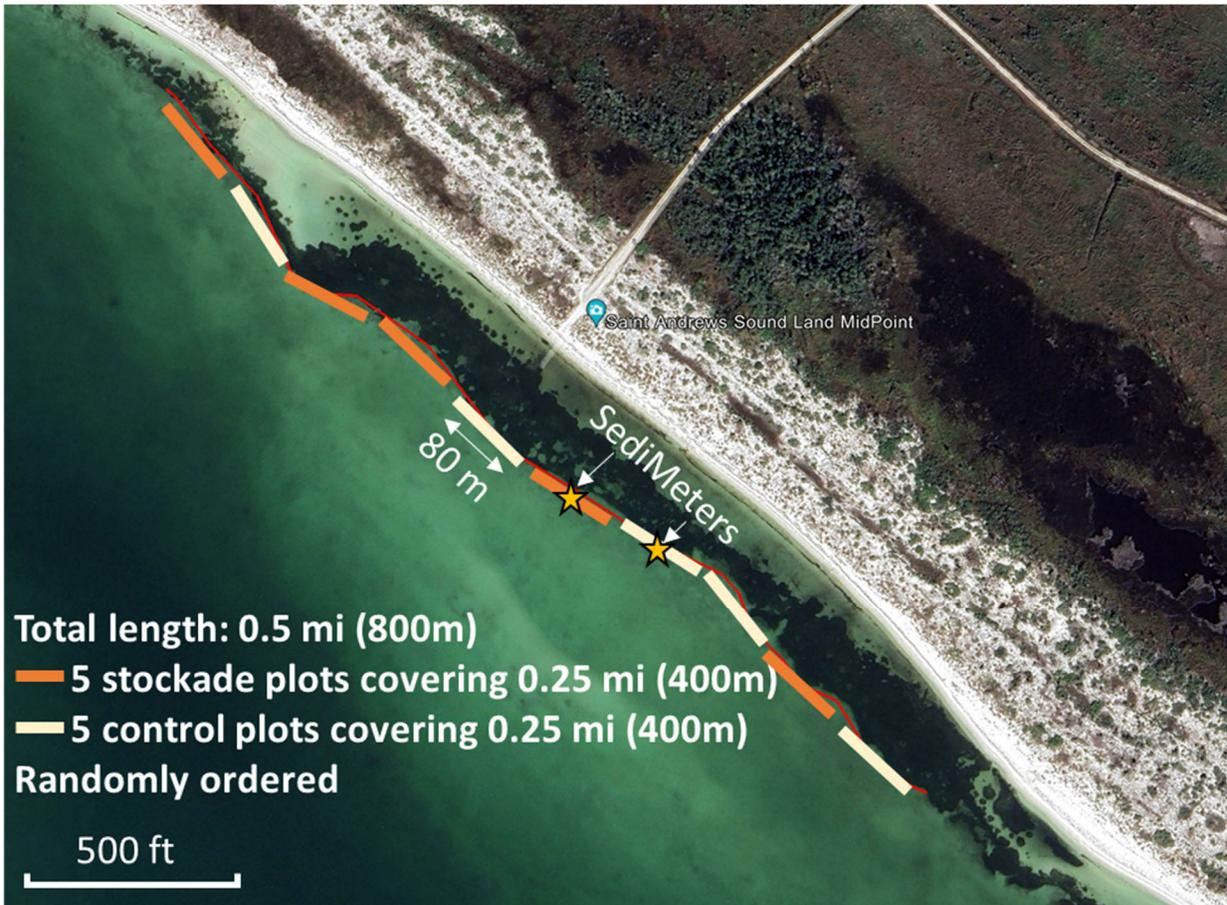
**Figure 5.** Proposed set-up spans 0.5 linear miles and includes 5 stockade plots (0.25 total linear miles) and 5 control plots (0.25 total linear miles).

The area will be divided into 5 plots with the bamboo stockade treatment and 5 control plots to be able to monitor the effects. Plots will be 80 m long, resulting in a total stockade treatment length of 400 m (0.25 mi), which is the RESTORE goal (**Fig. 5**).

- Measure the length of each PVC and/or measure the depth of deployed sediment plates (per Bell et al. 1999)
- Install two SediMeters coupled with tilt current meters: one set within a stockade plot and one set within a control plot (**Fig. 5**). The two sets will be deployed in two plots and changed to a different pair of plots after a month, to be able to collect data from different areas.
